SUBJECT: Animal Feeding Operation (AFO) Compliance Inspection for:  
- Buckeye Farms, County – Jackson, Facility #57426

# IOWA DEPARTMENT OF NATURAL RESOURCES AFO INSPECTION REPORT

Buckeye Farms  
4991 458<sup>th</sup> Avenue  
Preston, Iowa 52069  
Facility ID# 57426

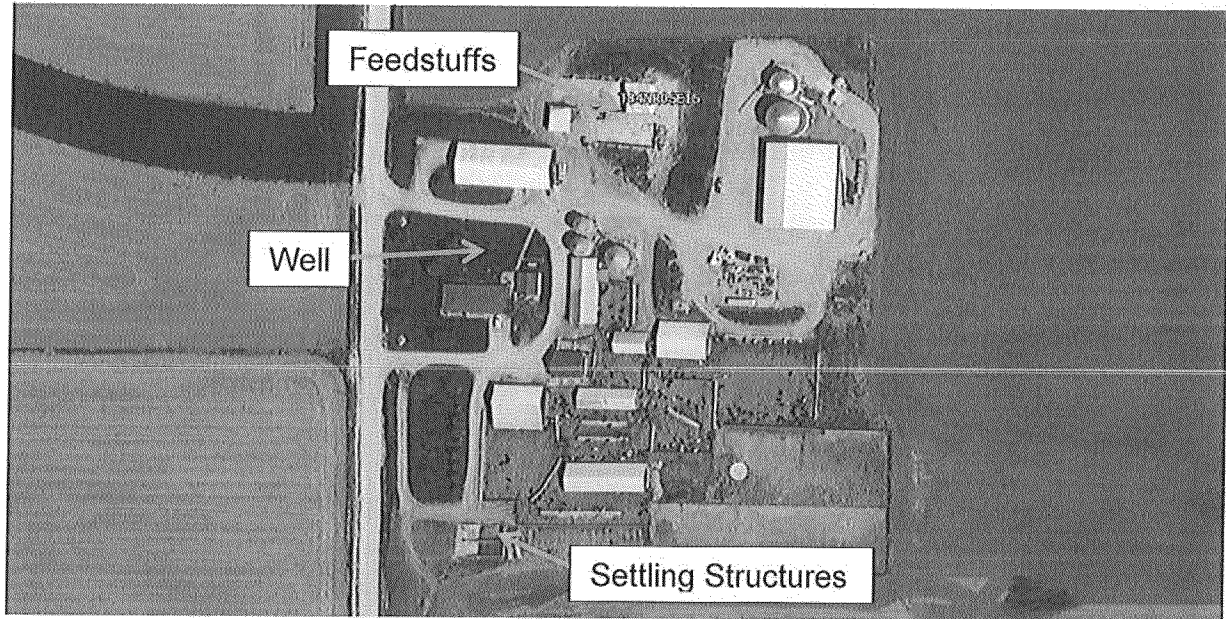
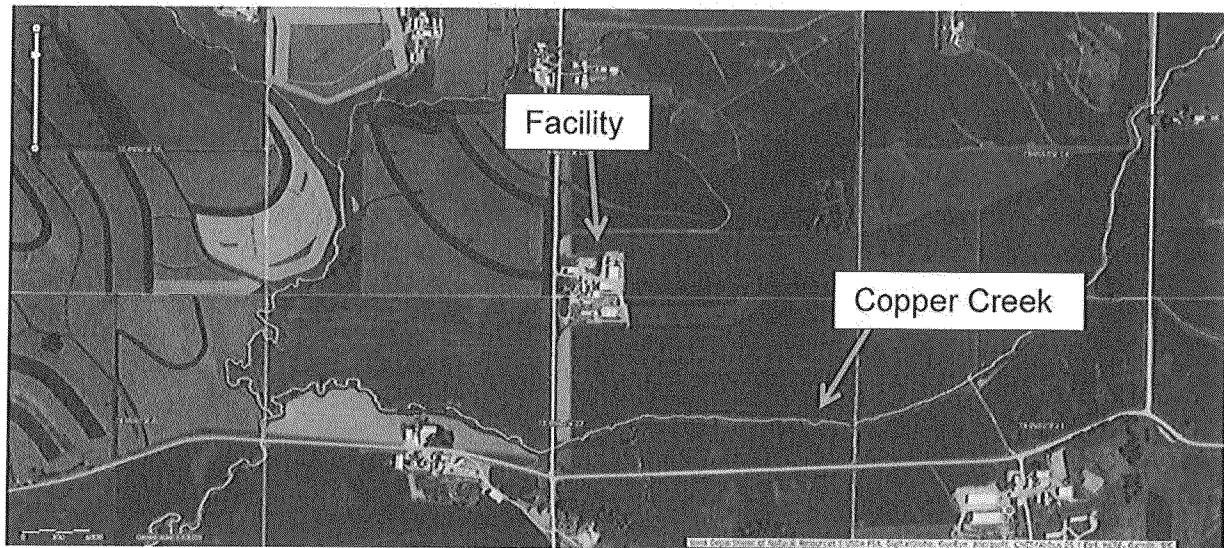
This facility consists of several concrete open feedlots housing a capacity of 700 beef cattle. Manure from the open feedlots is scraped and hauled to a stockpile in a field. Runoff from the open feedlots is directed into a series of concrete settling structures. Mortalities are disposed of by rendering. Mr. Tom Farrell, owner, was present and interviewed during the inspection.
